Manhole Inspection Summary

Manhole # S29GG_003MH

Insp Date: **1/2/07 10:27 AM**

Location Address: **1505 EUTAW PL** Cross Street: **MCMECHEN ST**

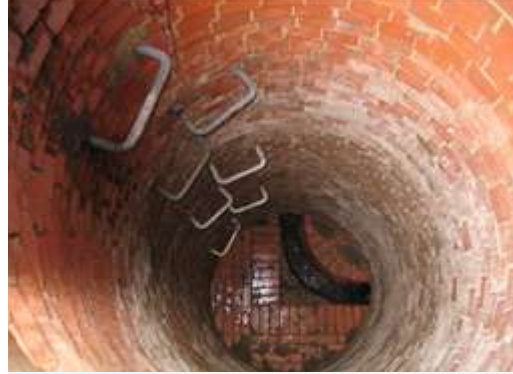
Top View

Adjustment and Barrel infiltration.
Evidence of surcharge - Bench debris.
Channel debris.

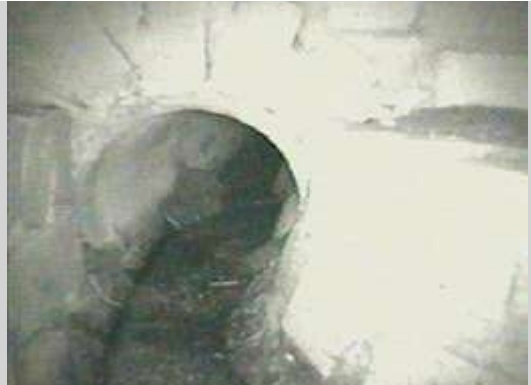
8 in. Circular Gravity Sewer Pipe Out @ 12 O'Clock

Deposits: ☐ None ☒ **Mud** ☐ Sludge ☒ **Debris** ☐ Grease

Silt Depth: **0.5** (in.) Deposits Extent: **Light**

Infiltration: **Evidence** Pipe Seal Cond: **Cracked**

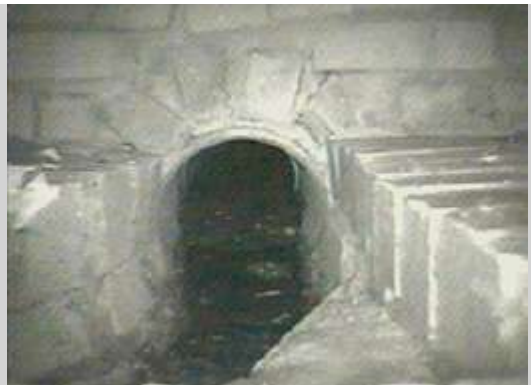
8 in. Circular Gravity Sewer Pipe In @ 3 O'Clock

Deposits: ☐ None ☒ **Mud** ☐ Sludge ☒ **Debris** ☐ Grease

Silt Depth: **1** (in.) Deposits Extent: **Light**

Infiltration: **Evidence** Pipe Seal Cond: **Unknown**
